Scottish Single Survey

Property address	61a Gilmore Place Edinburgh EH3 9NT	
------------------	---	--

Prepared by	Shepherd Chartered Surveyors
-------------	------------------------------

Date of inspection	06/06/2025

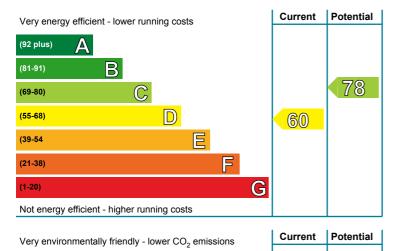
Energy Efficiency Rating

This graph shows the current efficiency of your home, taking into account both energy efficiency and fuel costs. The higher this rating, the lower your fuel bills are likely to be.
